SAUL RUN DAM

NDI No. PA 00251  
PennDER No. 43-48

PHASE I INSPECTION REPORT  
NATIONAL DAM INSPECTION PROGRAM

Saul Run Dam, Mercer County, Pennsylvania  
NDI NO. PA 00251, PennDER NO. 43-48  
Saul Run  
Date Inspected 7 December 1978

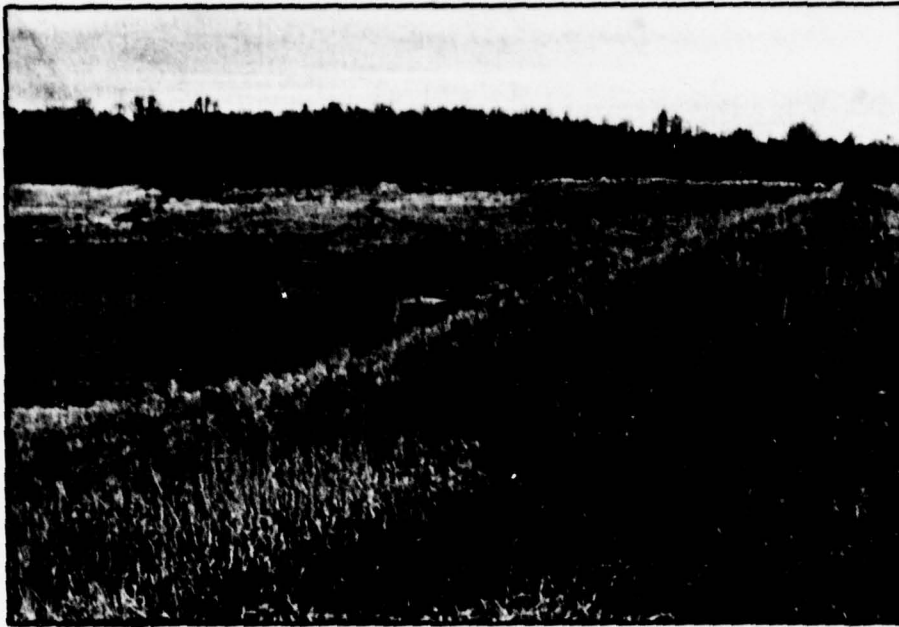
**PHOTO 1. View West at Spillway Entrance**

Photo 1 - View West over Pond, Intake Structure, and Upstream Slope of Dam at Spillway Entrance (Top Left-Center of Photo) from Dam Crest
